# **EPA/OSHA JOINT CHEMICAL ACCIDENT INVESTIGATION REPORT**

**BPS, Inc.  
West Helena, Arkansas**

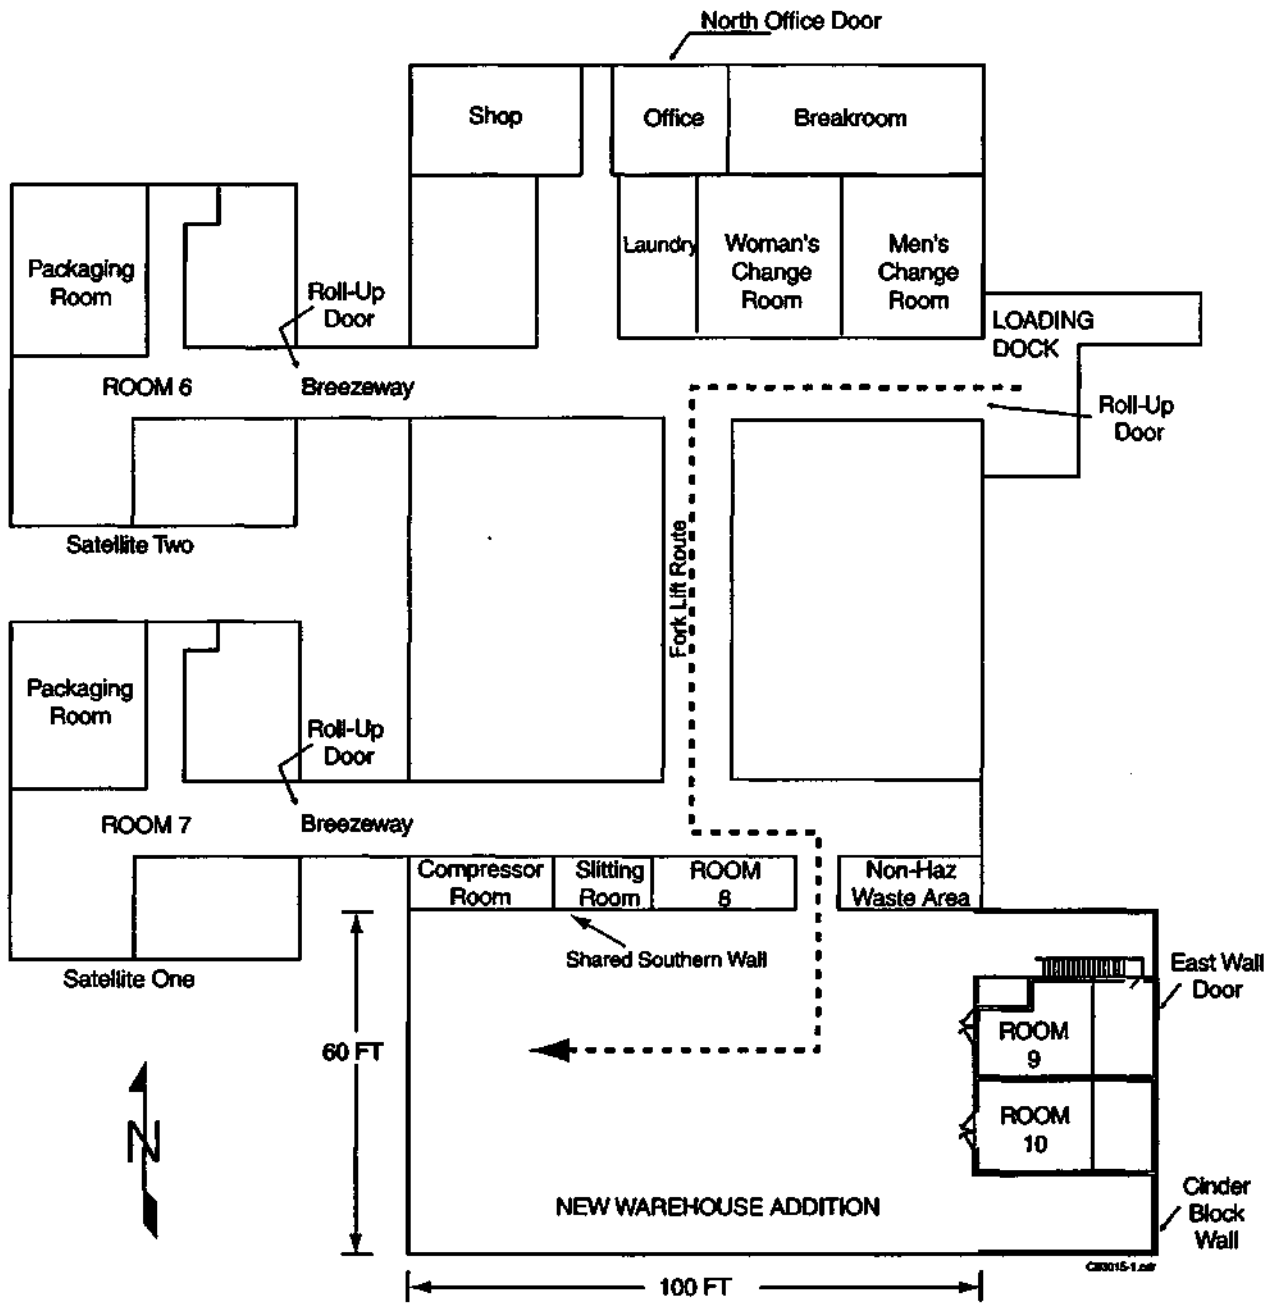
FIGURE 1: FLOOR PLAN - BPS, INC. UNIT #2

The West Helena facility employs approximately 130 workers. At the time of the incident 65 employees were on duty. The facility consists of two production buildings (referred as units One and Two), two satellite buildings, and a "gel" building. The production buildings are constructed of corrugated metal with steel reinforcement. The Unit Two building (Figure 1),

in which the incident occurred, had a 100' x 150' main area, a 16' x 34' loading dock, and two 50' x 60' satellite buildings connected to the main area by breezeways. In October 1995, a warehouse addition was added to the Unit Two building. It shared the southern wall of the original building (referred to as the new warehouse addition north wall). The addition was approximately 7800 square feet. It was also constructed of corrugated metal with the exception of the outside eastern wall. This particular area had two stories with an exterior (eastern) wall constructed of cinder blocks.

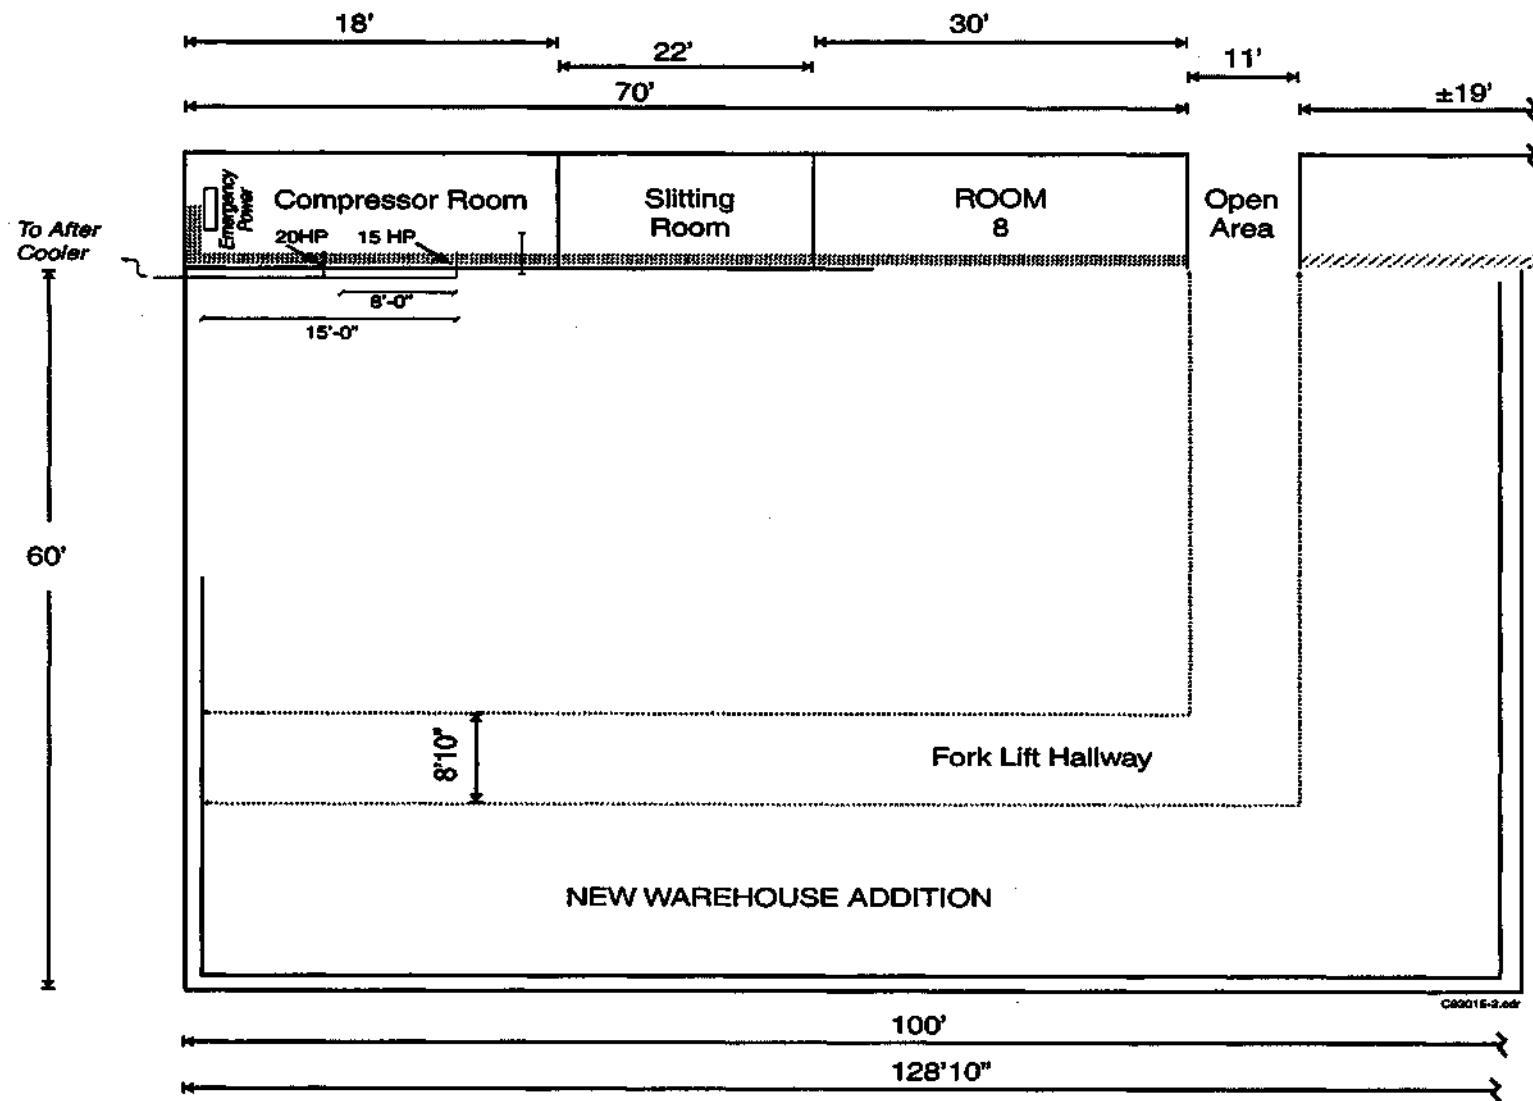
FIGURE 2: NEW WAREHOUSE ADDITION COMPRESSOR SYSTEM

Repackaging operations in the Unit Two building required the use of two reciprocating air compressors. The compressors were located in the southern portion of the original building. The compressors' discharge pipes went through the new warehouse addition's north wall into a common header pipe (Figure 2). This header pipe was fifteen feet long and 5'11" from the concrete pad floor. It ran parallel to the north wall to meet an after cooler outside the new addition's west wall. The output from the after-cooler was piped back along the same wall 3'7" from the concrete floor carrying the cooled air back to the accumulator tanks under each compressor (Figures 3 and 4).

Two multistage reciprocating air compressors were used in the Unit Two building. As stated previously, these compressors discharged into a common header pipe that was located on the warehouse side of the wall, approximately five feet above the deck. This header was 15 feet long and led to an after-cooler outside the building. The 15-hp unit suffered substantial damage during the incident. After the explosion, this unit was found lying on its side with no lubricating oil in the crankcase. The concrete foundation by the compressor had substantial heat damage and spalling in a configuration that suggested a liquid had burned on the surface. The 20-hp unit had only moderate damage, remained in its upright position after the event, and had a substantial amount of oil in the crankcase.

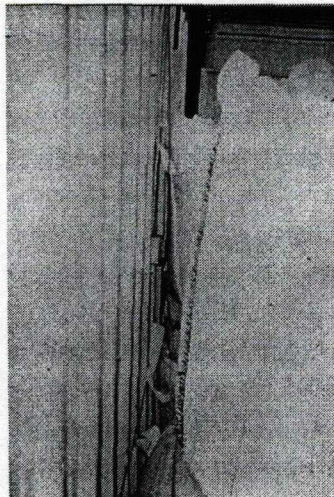
Figure 5. Supersack set-up at BPS Unit One

Shortly after the incident, BPS employees and management identified the decomposing material as an AZM supersack placed against or close to the hot compressor discharge pipe. The JCAIT confirmed that supersacks of materials were being spotted in close proximity or against walls at BPS. After the incident, JCAIT observed supersacks spotted along the wall in the Unit One warehouse. In this case, the supersacks were stacked two-high. The edge of the bottom supersack was within inches of the wall. The top supersack was listing so that it was in contact with the wall (Figure 5).

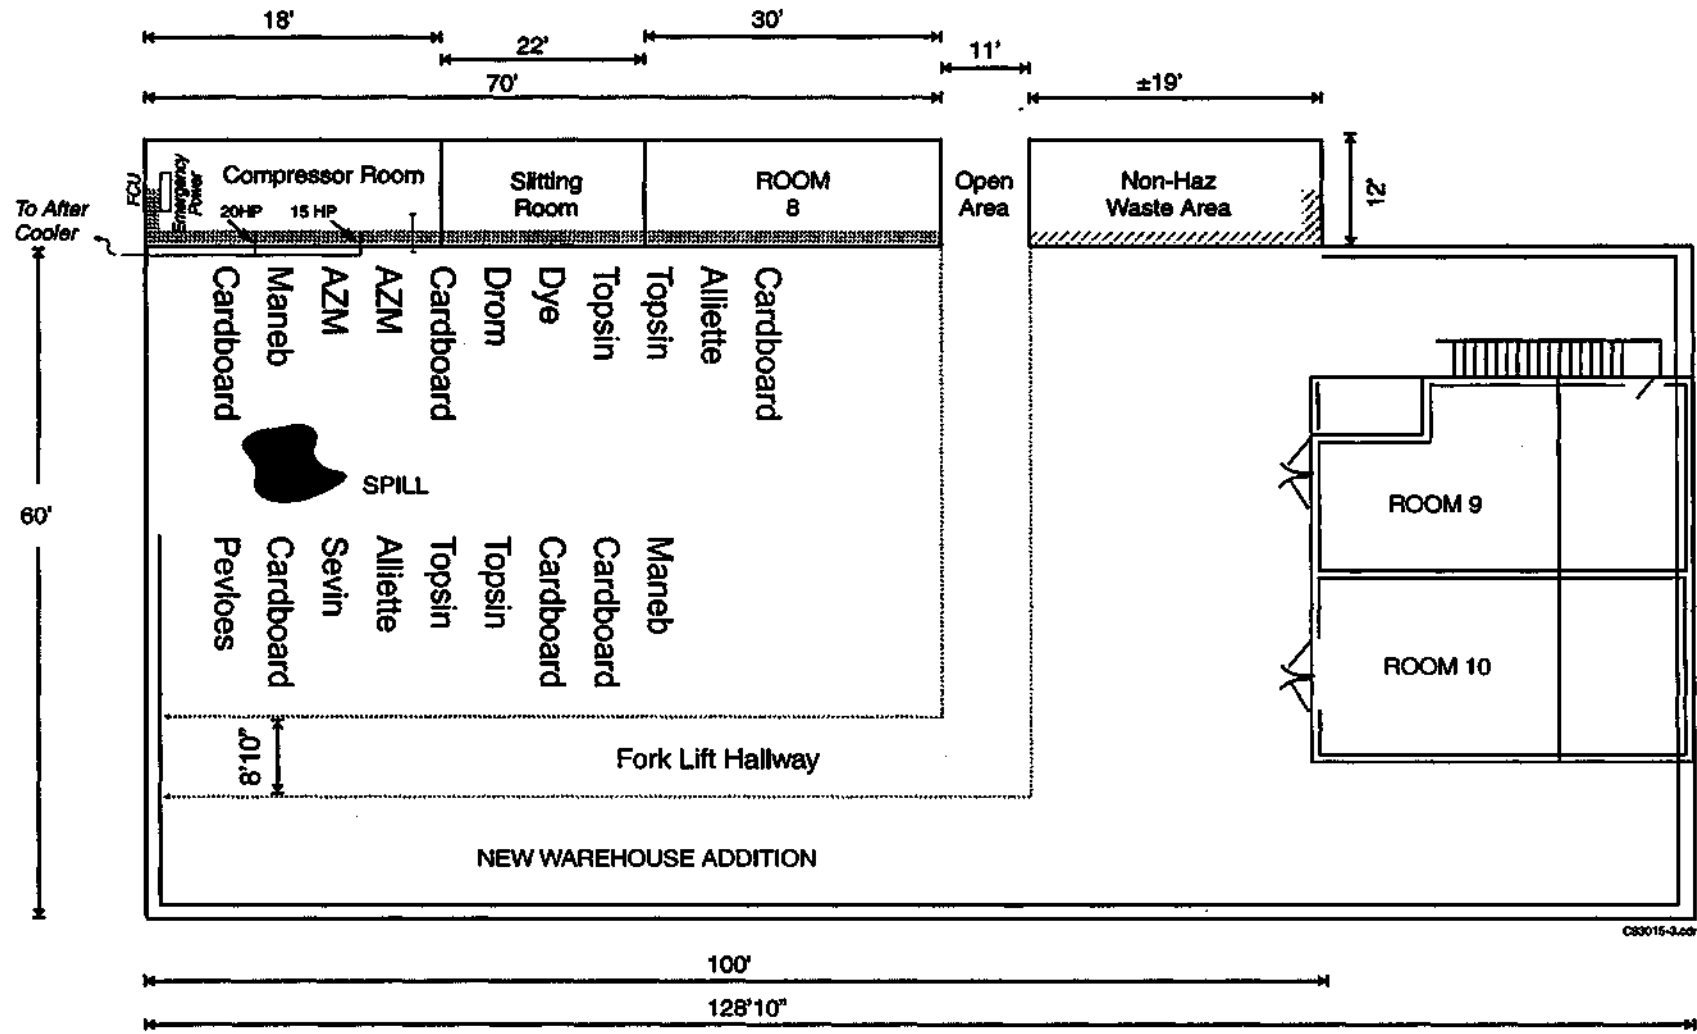
FIGURE 7: APPROXIMATE LOCATION OF CHEMICALS IN THE NEW WAREHOUSE ADDITION.

Based on witness interviews, the JCAIT identified the approximate location of the chemicals in the warehouse area (Figure 7). Even though witness accounts are somewhat conflicting regarding the quantity and approximate location of the stored chemicals, most statements agree that AZM supersacks had just been placed next to the compressor piping. Witnesses also agree that the yellow smoke or powder was coming from this location. Forklift operators recollect placing Maneb pallets by the compressor pipe in an attempt to make room for the incoming AZM. In addition to the witness statements the JCAIT:

- Screened the bulk residue samples for various pesticides including AZM, Maneb, Topsin, and Sevin. Only semi-quantitative values of AZM and Maneb were reported.
- Secured and analyzed the remains of the new warehouse addition ventilation fans which had visible yellow residue (Figure 8). AZM and its major decomposition products were confirmed.

The JCAIT concluded that it was highly probable that pallets of both AZM and Maneb were placed along the compressor pipe the day of the event.

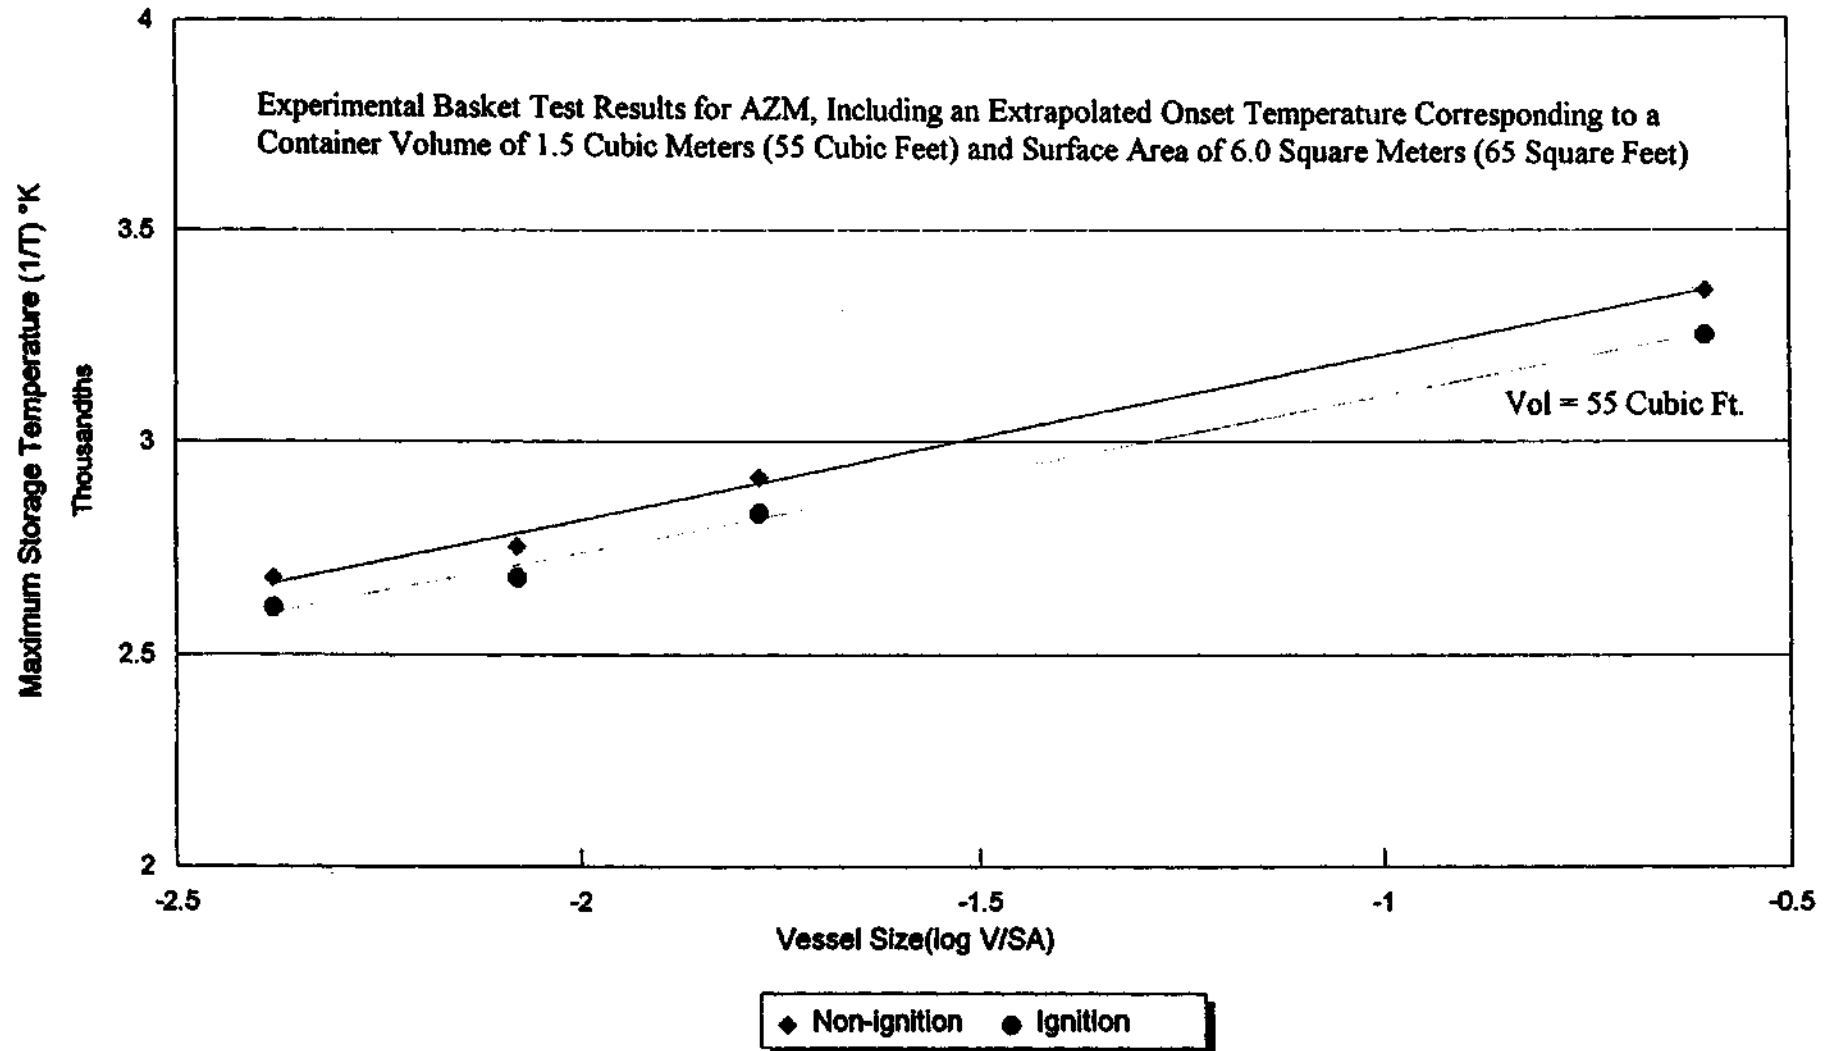
ICF Kaiser - AZM

- A basket test to determine safe storage temperatures for bulk AZM 50W showed decomposition of the sample beginning between 158°-176° F (70°-80° C). The decomposition temperature corresponds to an estimated safe storage temperature of 79° F (26° C), using a 10% safety factor, based on volume and surface area specifications for supersacks provided by MFC. It should be noted that the test does not predict a safe time interval corresponding to this temperature.
